Inner Surface Structure of Ultra ALLOY® Metal Capillary Columns (Contamination durability)

Keywords : Inner Surface Structure, Elemental Analysis, SEM Image, Contamination durability

Products used : Multi-functional pyrolyzer, Ultra ALLOY® metal capillary columns

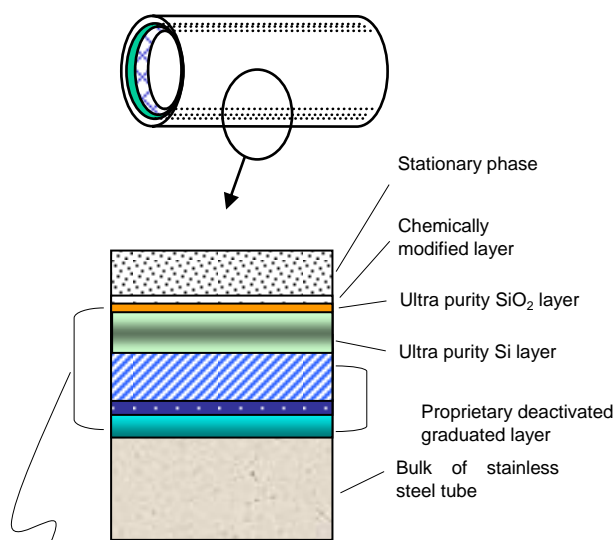
Fig.1 Cross Sectional view of Ultra ALLOY® Metal Capillary Column's Inner Surface Model

5~7 layer graduated multi layers
(Adjacent layers are chemically bonded and the interface between layers has graduated concentrations of both layers.)

- 1) The column inner surface is a chemically bonded graduated multi layer structure.
(Fig. 1 shows a cross sectional view of the column's inner surface. This surface structure provides high flexural and impact strength, and also has a resistance against sharp changes in temperature.)
- 2) The top layer is ultra pure SiO₂. (Refer to the element composition determined by Auger analysis shown in Fig.2)
- 3) Rough column surface has surface area tens of times larger than FS.
(See rough surface structure shown in Fig. 3. This is reason of the high durability of contaminants. See UAT-005E)

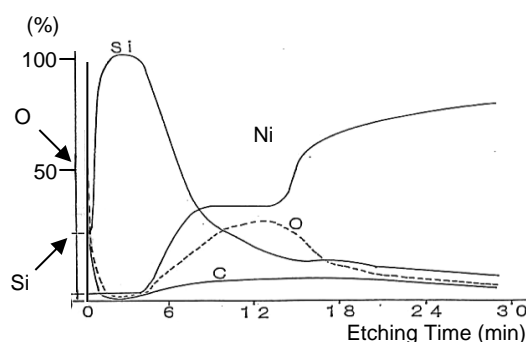
Fig.2. Auger Analysis of Graduated Multi Layer Surface (Element composition of top surface is SiO₂, and inner layers contain silicon.)

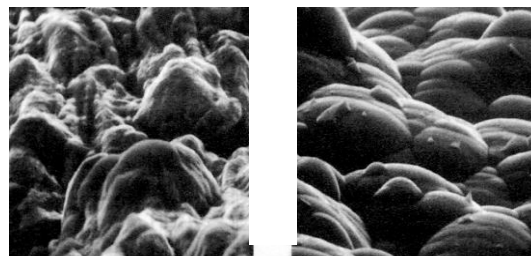
Before treatment → After treatment

Fig.3 SEM Image of Inner Surface
(Note rough surface even after treatments)
